Advanced Tree Care

250 Bonita Rd, Portola Valley

June 9, 2020

At your request I visited the above site for the purpose of inspecting and commenting on the regulated trees around the property. A new landscape is planned, prompting the need for this tree protection report.

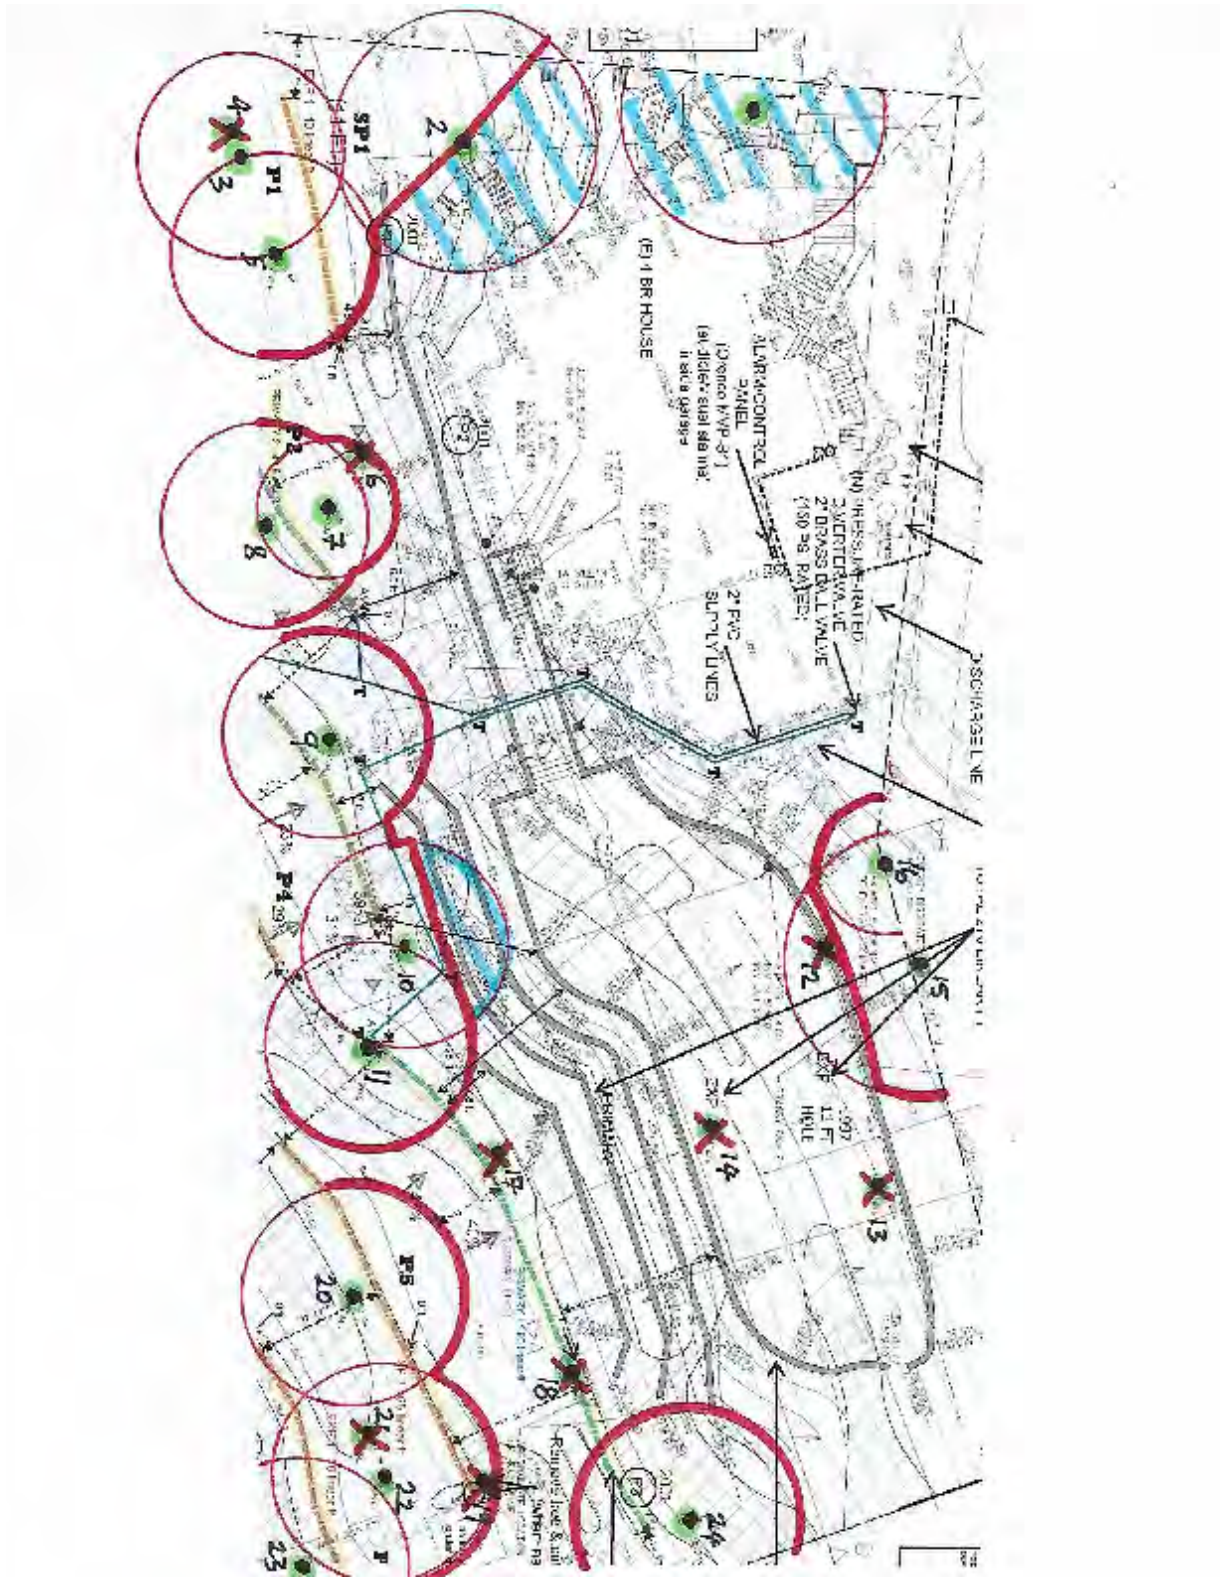
Location of proposed new landscape, protected trees and their Tree Protection Zones

If the fencing were installed, the new landscape improvements would be unbuildable. The solid red line on the drawing shows a possible location of the fencing and areas shaded in blue where construction would be in conflict with the TPZs.

The proposed leach field lines are highlighted in yellow on the first drawing. The lines weave through the TPZs of Tree #s 3 and 5, 7 and 8, 9 and 10, 11 and 24, 20, 22 and 23. The leach field lines are located as best possible through the trees. The lines will be dug with small machinery going through the TPZs. The pathway for the small machinery is marked on the second drawing in purple. Machinery should not track any closer than 3 feet from the trunks of the trees. The machinery should track on plywood and wood chip to the location of excavation to avoid compaction of the roots within the TPZs. If the TPZ fencing is to be removed to access the trenching, trees close to the pathway for small machinery should be wrapped with 4 layers of snow fencing and wooden slats as shown in the photograph for Type III tree protection fencing. This will prevent any accidental damage to the trunks of the trees.

1. The Tree Protection Zone (TPZ) should be defined with protective fencing. This should be cyclone or chain link fencing on 1 1/2" or 2" posts driven at least 2 feet in to the ground standing at least 6 feet tall. Normally a TPZ is defined by the dripline of the tree. I recommend the TPZ's as follows, they are marked in a dotted red line on the drawing:-

A pathway is proposed within the TPZs of 1 and 2. The pathway will consist of compacted crushed gravel. Excavation depth should not exceed 6" in depth. If roots greater than 2" in diameter are encountered, they should be worked around and not cut. All recommendations should be followed when working in areas shaded in blue.
