California Tree and Landscape Consulting, Inc.

August 19, 2021

ARBORIST REPORT, TREE INVENTORY, CONSTRUCTION IMPACT ASSESSMENT AND TREE PROTECTION PLAN

RE: 411 Crest Drive, Emerald Hills, County of San Mateo, California [APN 057-203-050]

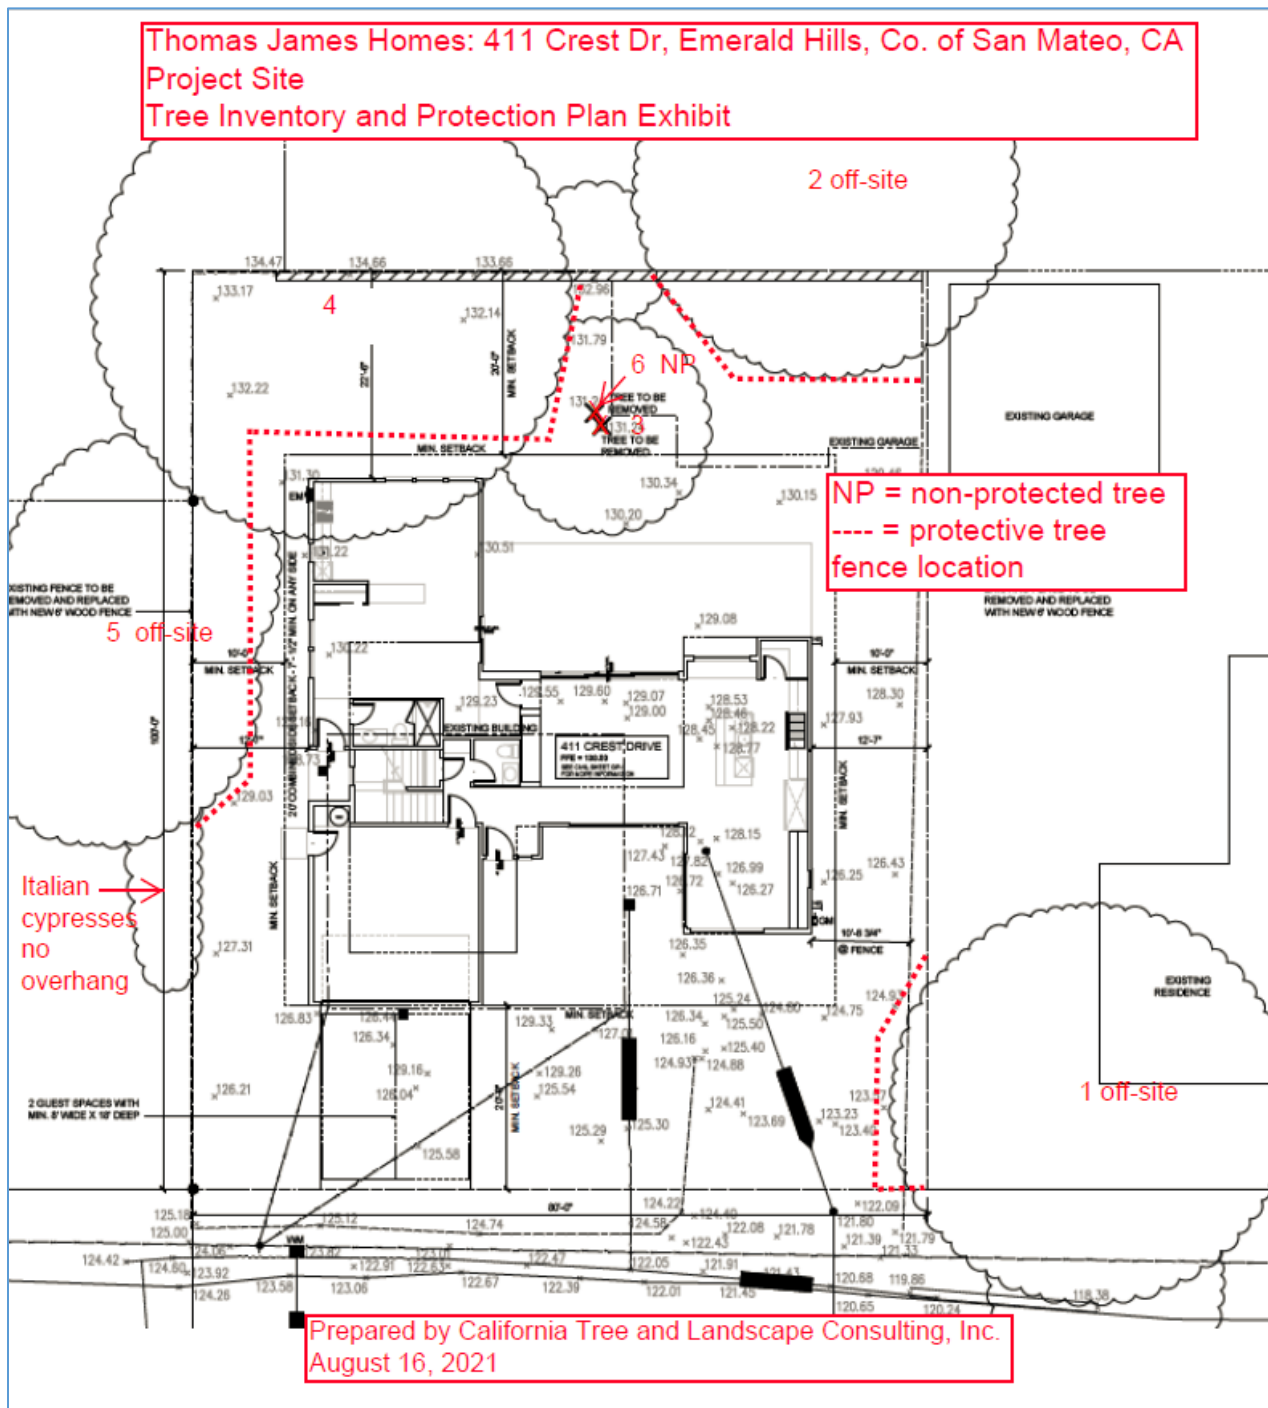
APPENDIX 1 – TREE INVENTORY AND PROTECTION PLAN EXHIBIT

Tree # 1 (Tag # 9555): No impact is expected from development.

Tree # 2 (Tag # 9556): Slight impact to the CRZ and canopy are expected from demolition of the existing garage/outbuilding.

Tree # 3 (Tag # 9557): This tree is to be removed for development.

Tree # 4 (Tag # 9558): Moderate impact to the canopy is expected due to encroachment.

Tree # 5 (Tag # 9559): Slight impact to the CRZ and canopy are expected from demolition of the existing house.

Tree # 6 (Tree not tagged): This is a non-protected tree to be removed for development.

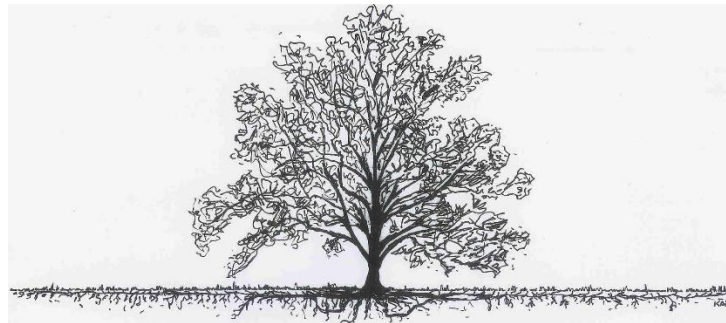
Drawing A

Common misconception of where tree roots are assumed to be located

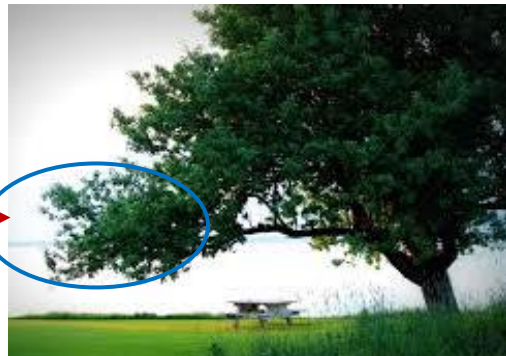
Over weight, reaching limb with main stem diameter small compared with amount of foliage present
