Kielty Arborist Services LLC

June 6, 2018

Site: 1462 Edgewood Road, Redwood City, CA

As requested on Wednesday, May 16, 2018, I visited the above site to inspect and comment on the trees. A subdivision is proposed for this site and your concern for the future health and safety of the trees has prompted this visit.

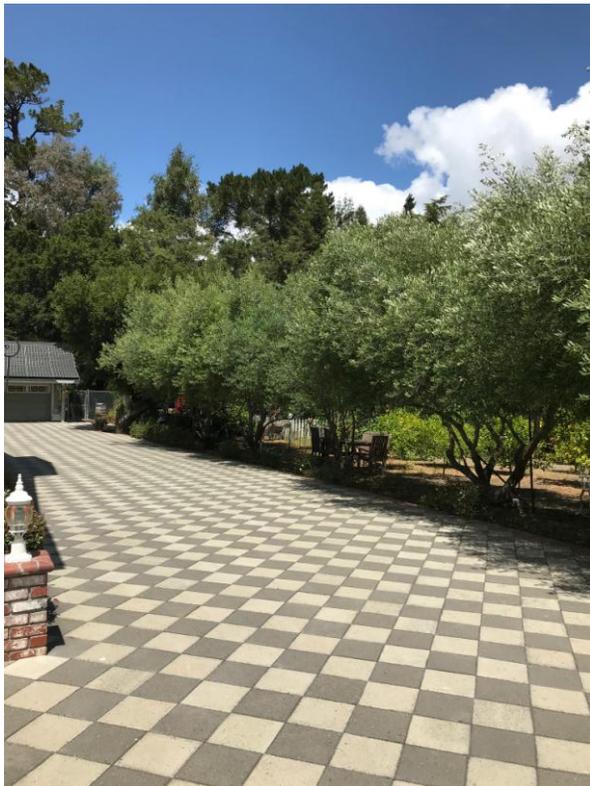
Olive trees #7-12 are located in close proximity to the proposed subdivision property line on the south side of the property. These trees are not protected in San Mateo County due to their diameter measurements. All of the olive trees are in excellent condition with no obvious form or health flaws. These trees will provide an excellent screen at the property line and should be retained for this reason. Olive trees are very drought tolerant and require little to no irrigation.

Showing olive trees at the proposed property line

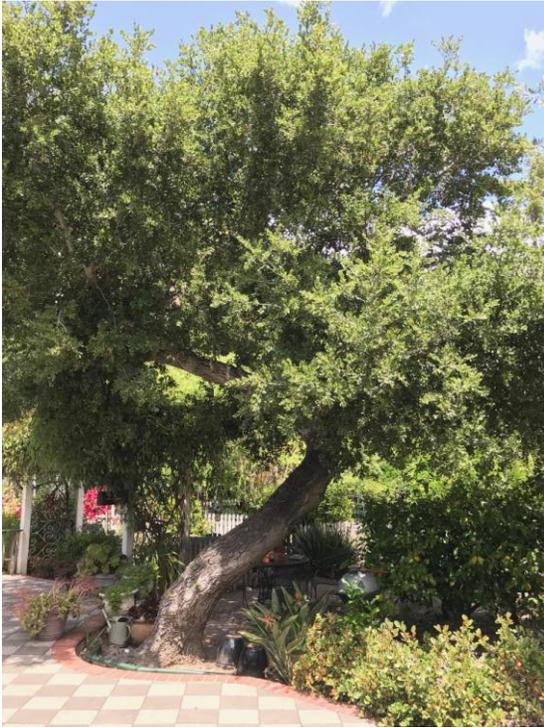
Showing oak tree #13

Coast live oak tree #13 is in good condition and is aesthetically pleasing. The tree is located at the proposed property line and offers screening for the property. The tree has a contorted trunk and leans into the property. The tree has a restricted root zone due to the neighboring driveway. Root growth is often discouraged due to the compacted conditions of the available soil underneath the neighboring driveway. Roots on the tension side of a trees lean are needed for the stability of the tree more than roots on the compression side. Because roots on the tension side of the trees lean are growing under compacted conditions, it is recommended to prune this tree every 3-5 years using acceptable reduction cuts in the direction of the tree's lean. This will keep the tree at a manageable size. Also, this tree is a perfect candidate for the installation of a prop to offer extra support due to the tree's lean. With these mitigation measures put into action the trees risk of future failure due to the tree's lean would be significantly reduced.

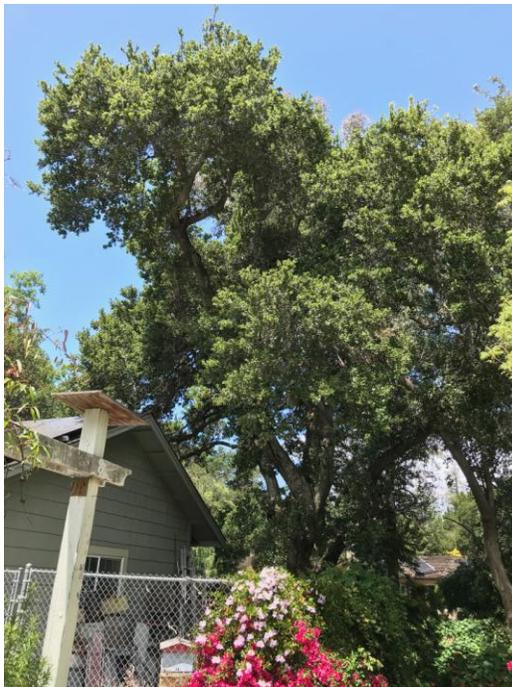
Showing oak tree #14

Coast live oak tree #14 is located near the rear of the property and is in good condition. During my inspection I noticed the root crown of the tree was buried. Minor sycamore borer damage was also observed near the base of the tree. It is recommended to expose the tree's root crown to inspect for any signs of oak root fungus, as buried root crowns can lead to oak root fungus diseases. The root crown should remain exposed. The tree is codominant at 7 feet with a good union formation. The tree has been pruned in the past for structure clearance, as the tree is heavy over the neighbor's garage. The tree has grown heavily to the south as it is being suppressed by a eucalyptus tree(#15) to the north. It is recommended to heavily prune the eucalyptus tree so that the oak tree can put on growth to the north, creating a more balanced tree crown. This tree will need to be maintained using approved reduction cuts to reduce the risk of leader failure on to the neighboring garage every 3-5 years. Also, if possible the leaders should be cabled for extra support.

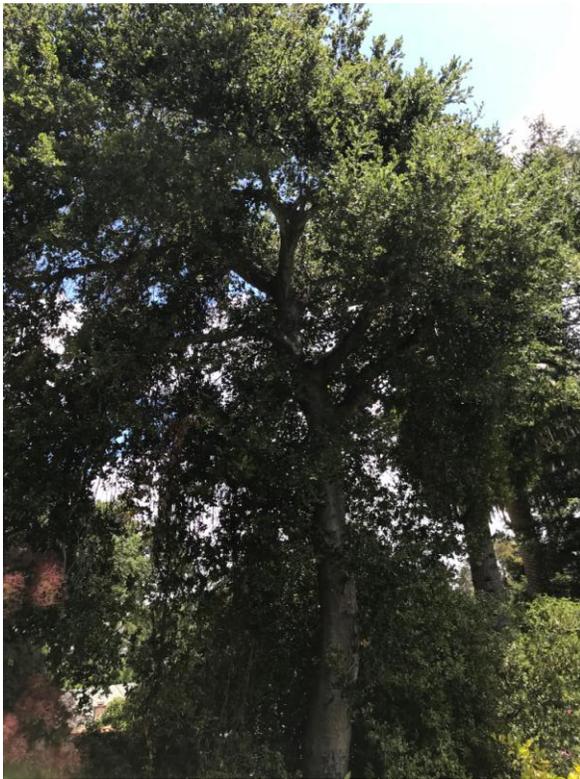
Coast live oak tree #17 is in excellent condition. No obvious form flaws were visible within the tree's canopy. This tree is a significant tree and will be required to be protected during all stages of construction. The following tree protection plan will help ensure the safety and health of the retained trees on site. Once a site plan has been made available the tree protection plan shall be amended to be more specific.

Showing oak tree #17
