California Tree and Landscape Consulting, Inc.

August 19, 2021

ARBORIST REPORT, TREE INVENTORY, CONSTRUCTION IMPACT ASSESSMENT AND TREE PROTECTION PLAN

RE: 411 Crest Drive, Emerald Hills, County of San Mateo, California [APN 057-203-050]

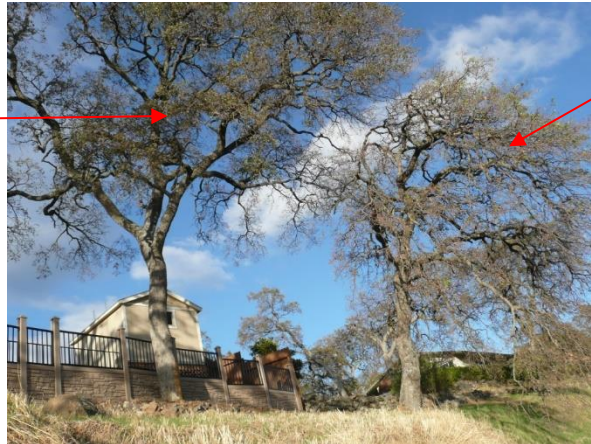
Suppressed Tree

Limited space for canopy development produces poor structure in trees. The largest tree in a given area, which is 'shading' the other trees is considered Dominant. The 'shaded' trees are considered Suppressed. The following picture illustrates this point. Suppressed trees are more likely to become a potential hazard due to their poor structure.

Canopy weight all to one side
